ok
**(OPERATION OF A FORCED CIRCULATION,
HAYNES ALLOY NO. 25, MERCURY LOOP
TO STUDY CORROSION PRODUCT
SEPARATION TECHNIQUES)**

OPERATION OF A FORCED CIRCULATION, HAYNES ALLOY NO. 25,
MERCURY LOOP TO STUDY CORROSION PRODUCT
SEPARATION TECHNIQUES

This report is concerned with the construction, operation, and evaluation of a forced circulation mercury loop designed to investigate corrosion product separation techniques in a Haynes alloy No. 25 system. The work was performed between May 1962 and April 1964 in support of the Sunflower program under NASA Contract NAS 5-462 with Mr. Jack A. Heller, Space Power Systems Division, NASA Lewis Research Center, as Technical Manager. The report was originally prepared as Thompson Ramo Wooldridge Report ER-5985, May 1, 1964.

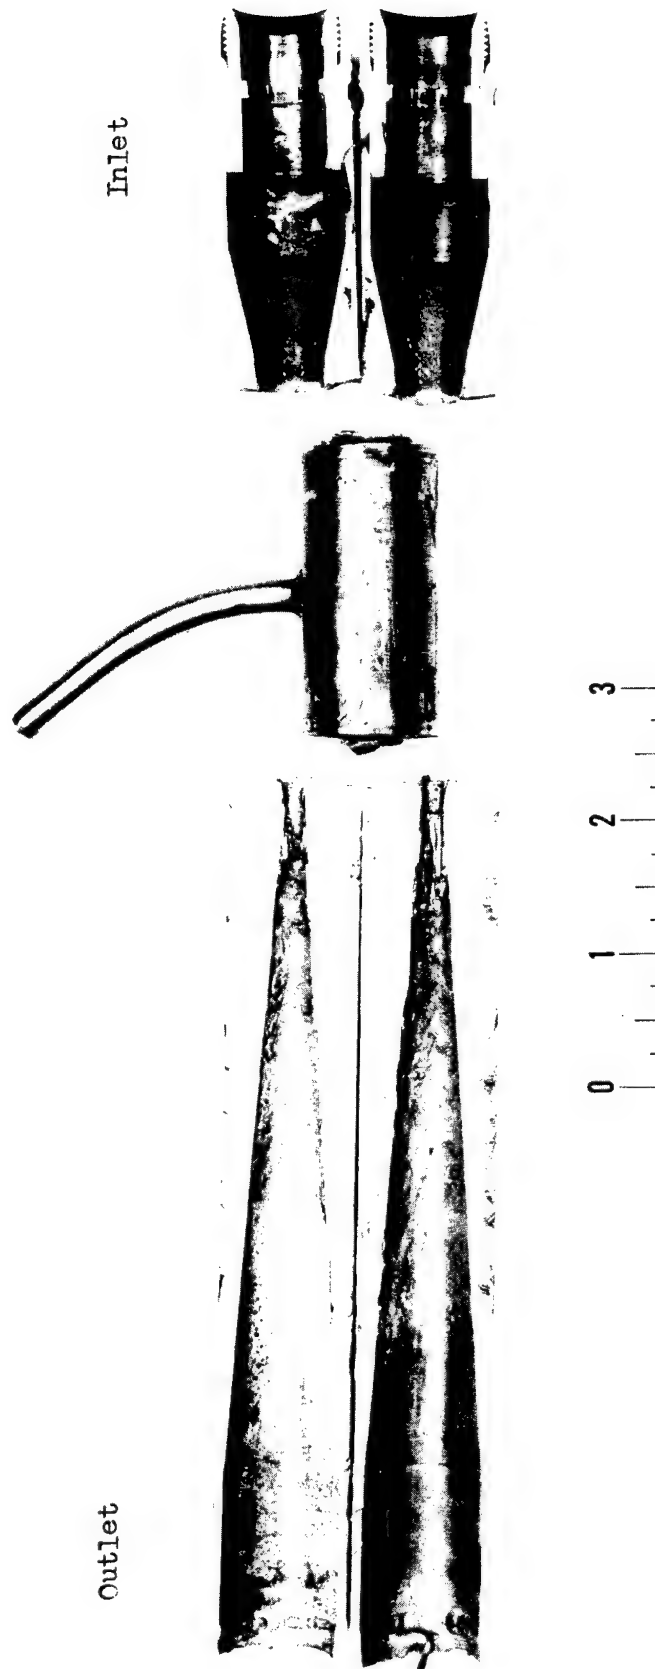
Figure 11. Deposition in Venturi.

As shown in Figures 11 and 12, the Venturi was found to contain an amalgam which was located on the outlet side in the vicinity of the orifice. The pre-heater (Sections 10, 11, and 12) also contained an amalgam, as shown in Figure 13. Photographs of the boiler are shown in Figure 14. As seen here, the boiler inlet contained a small quantity of a dark deposit while the mid-section and outlet again contained an amalgam. The amalgam extended into the superheater inlet, as shown in Figure 15. From this point on, as the mercury was dried and superheated, the quantity of deposit decreased until the superheater outlet was reached, where an amalgam was again present. The vapor corrosion product separator outlet tube and the superheater mid-section were essentially free of deposit, Figure 15.

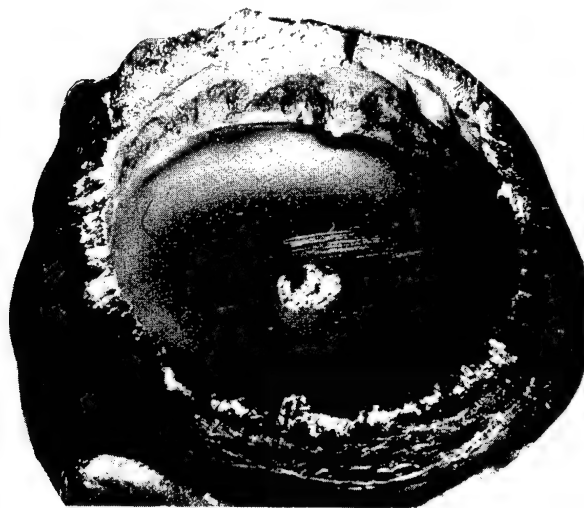
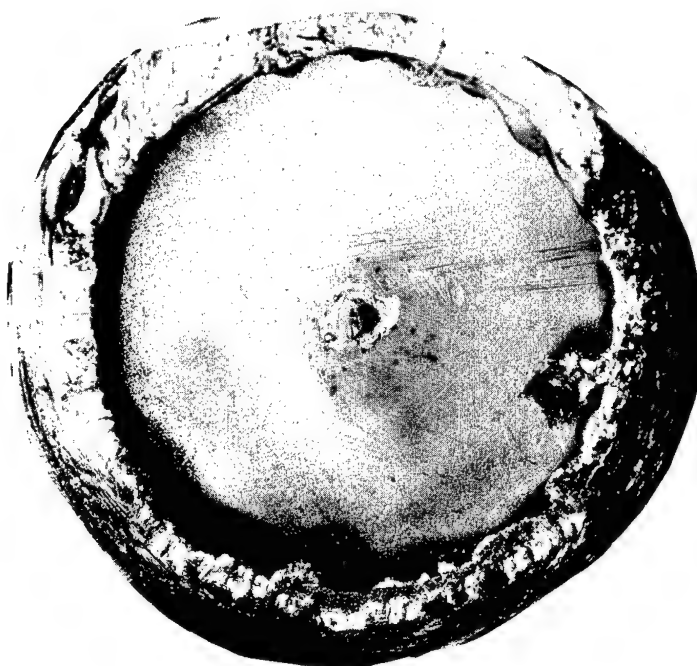
Figure 16. Deposit Found in Loop Orifice.

A hard deposit was found in the orifice and is shown in Figure 16. The deposit contained essentially no mercury and was blocking approximately 99.2 percent of the flow passage. The presence of this deposit accounts for the decrease in flow rate in the system during the final hours of operation. However, it is believed that the majority of this deposit was formed during the shut-down operation, since the change in flow rate did not reflect essentially complete blockage.

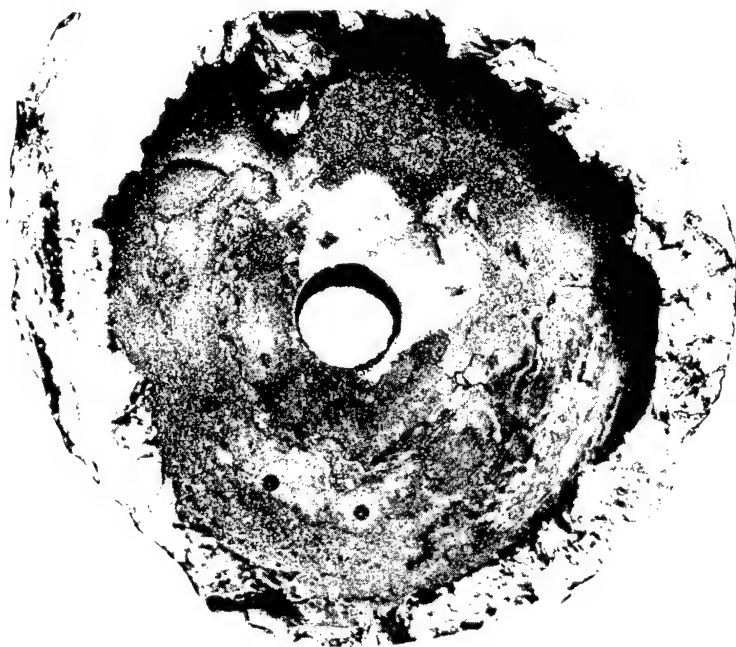
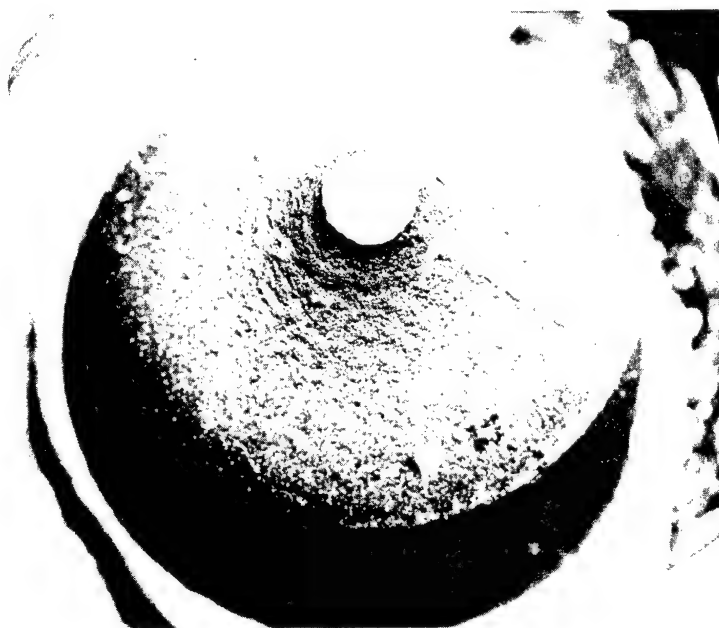
Figure 17. Deposit Found in Loop Nozzle.

The nozzle was also observed to contain a deposit, as shown in Figure 17. Although there was a small amount of deposition on the inlet side, the majority of the deposit was found on the outlet.

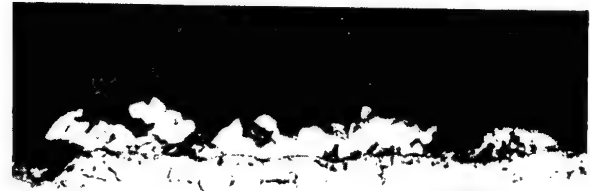
c) Section 8, TC 8 Boiler Inlet
(Layer Attack)

d) Section 7, TC 9 Boiler Mid-Section
(Deposition and Layer and Inter-
granular Attack)

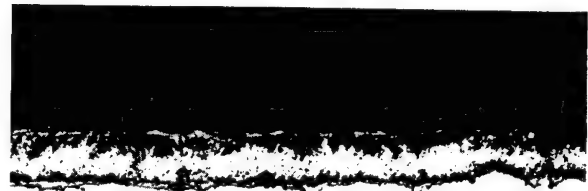
e) Section 7, TC 10 Boiler Mid-Section
(Layer Attack)

f) Section 6, TC 12 Boiler Outlet
(Layer Attack)

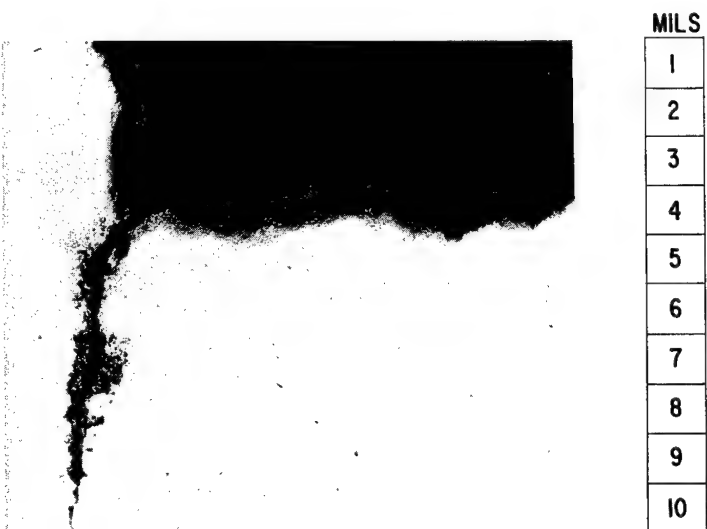
a) Section 5, TC 14
Weld; Superheater Inlet
(Layer Attack)

Haynes alloy No. 25 fusion welds appeared to be unattacked in all cases except in the vapor section (No. 5) of the boiler. Corrosion was present at the weld and in the crack, Figure 21a. Corrosion was manifested as a depleted layer.

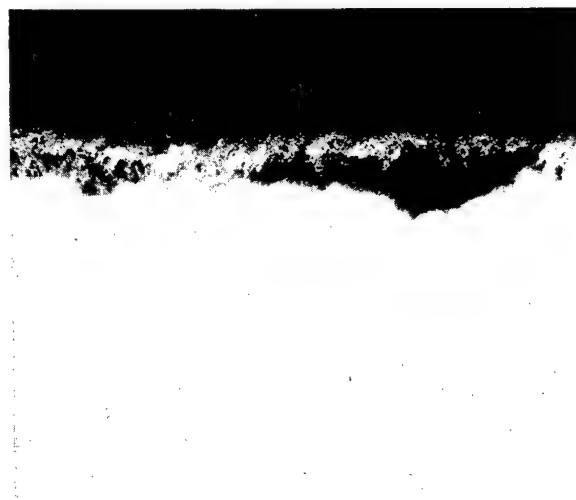
b) Section 5, TC 14
Superheater Inlet
(Layer Attack)

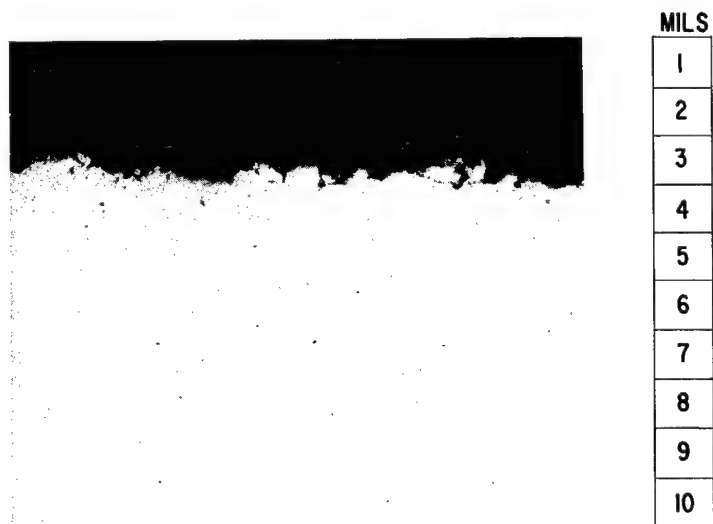
c) Section 5, TC 17
Superheater Inlet
(Crevice Attack)

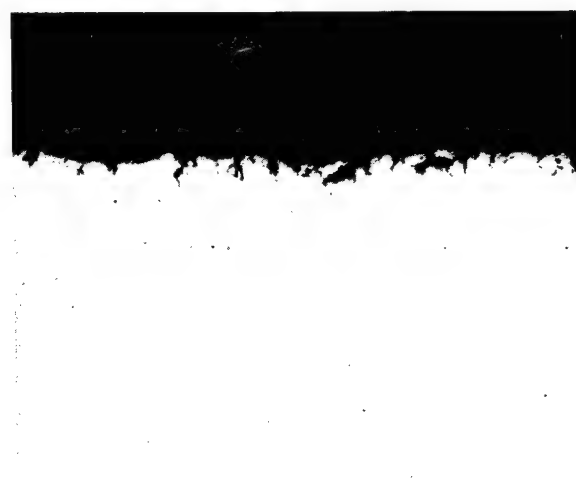
d) Vapor Corrosion Product
Separator Filter Tube
(Crevice and Intergranular Attack)

The vapor corrosion product separator was attacked to a depth of 1.9 mils in the 1130°F temperature zone. Corrosion was manifested as both intergranular and leached layer attack (see Figure 21d). Attack diminished to 1.1 mils penetration in the superheater mid-section as vapor quality improved, Figure 22a. Corrosion was of the crevice type. In the last quarter of the superheater (outlet), a substantial deposit was observed, Figure 22b. The maximum thickness of this deposit was seven mils. Swirl wire attack in the vapor portion of the loop generally was of the intergranular type and varied between 0.3 and 1.35 mils, Figures 23e and 24b and Table 3. Only the Haynes alloy No. 25 swirl wire in the vapor region contained cracks as contrasted to the lack of cracking in the liquid-contacted sections, Figure 24. The swirl wire was cold-worked as a result of swirl forming.

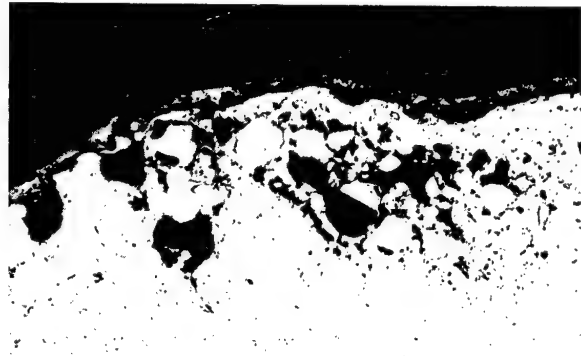
a) Section 2, TC 25
Superheater Mid-Section
(Crevice Attack)

b) Section 1, TC 27
Superheater Outlet
(Deposition)

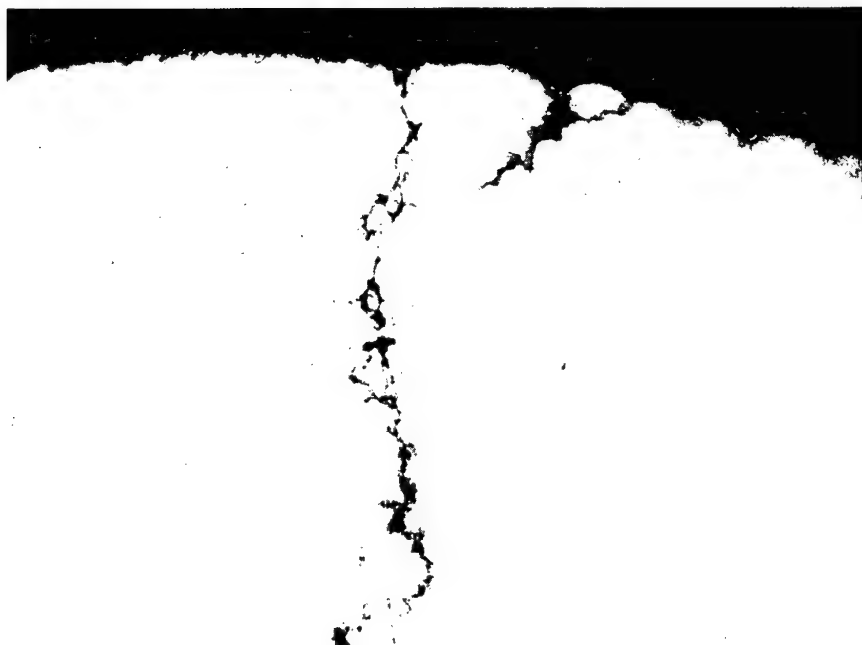
a) Section 6
Boiler Outlet
(Cracking and Layer
and Crevice Attack)

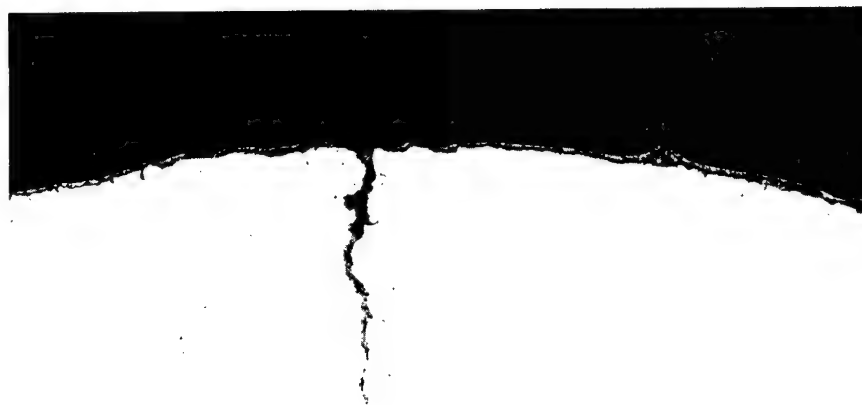
b) Section 2
Superheater Mid-Section
(Cracking and Intergranular Attack)

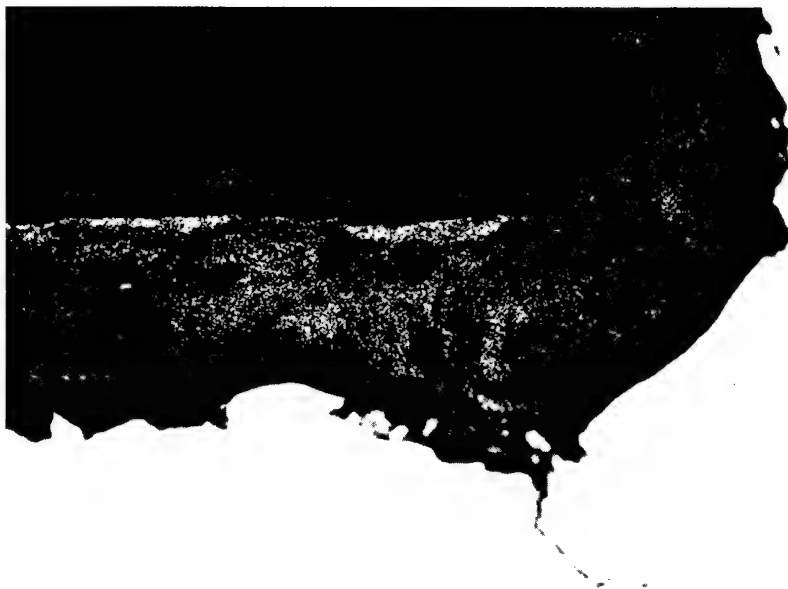
b) At Tube-Orifice Plate Junction

Figure 26. Cross-Section of Orifice on Inlet Side Showing Intergranular Attack Near Orifice Opening and a Leached Layer and Cracking at the Orifice Plate-Tube Junction. Magnification: 250X, Unetched.

Orifice corrosion was greatest on the inlet side near the wall and measured 7.3 mils in depth, Figure 25. Cracking was also observed at the orifice plate-tube wall junction, Figure 26b. Corrosion up to 1.1 mils in depth was also present on the orifice opening, Figure 26a. The corrosion was manifested as both layer and intergranular attack. The outlet side of the orifice contained deposits which adhered to the orifice wall. The attack was undoubtedly a result of mercury vapor condensation on the orifice plate, since immersion thermocouples recorded 796 and 867°F as the respective inlet and outlet temperatures. The severity of the attack could also be a result of erosive action by the condensing mercury vapor, which is not readily separable from corrosive attack.

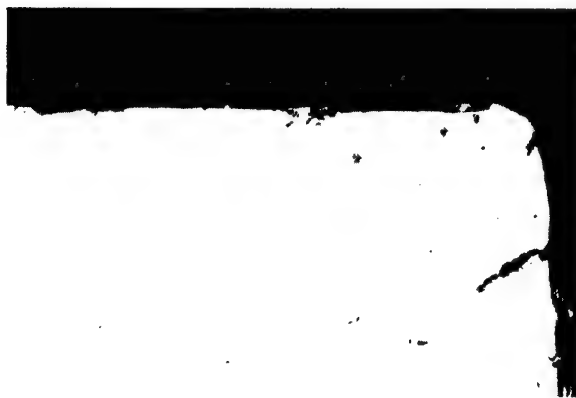
c) No. 3 Nivco 10
(Erosion and
Intergranular Attack)

d) No. 3 Nivco 10
(Deposition and
Intergranular Attack)

Corrosion was also evident in the eroded area. Erosion damage on PH15-7Mo in condition RH 950 (specimen No. 4) was less severe, 1.85 mils, Figure 28e. The increased resistance to erosion of specimen No. 4 over specimen No. 2 was probably the result of the greater hardness of specimen No. 4 (about 3 Rockwell C hardness units). Nivco 10 specimen No. 1 showed no signs of erosion. However, specimen No. 3 showed erosion up to 1.85 mils, Figure 28c.
